**Preliminary Assessment
of an
Identified Illegal Drug Laboratory
at:**

**20 Bluebird Lane
Bailey, Colorado 80421**

October 15, 2010

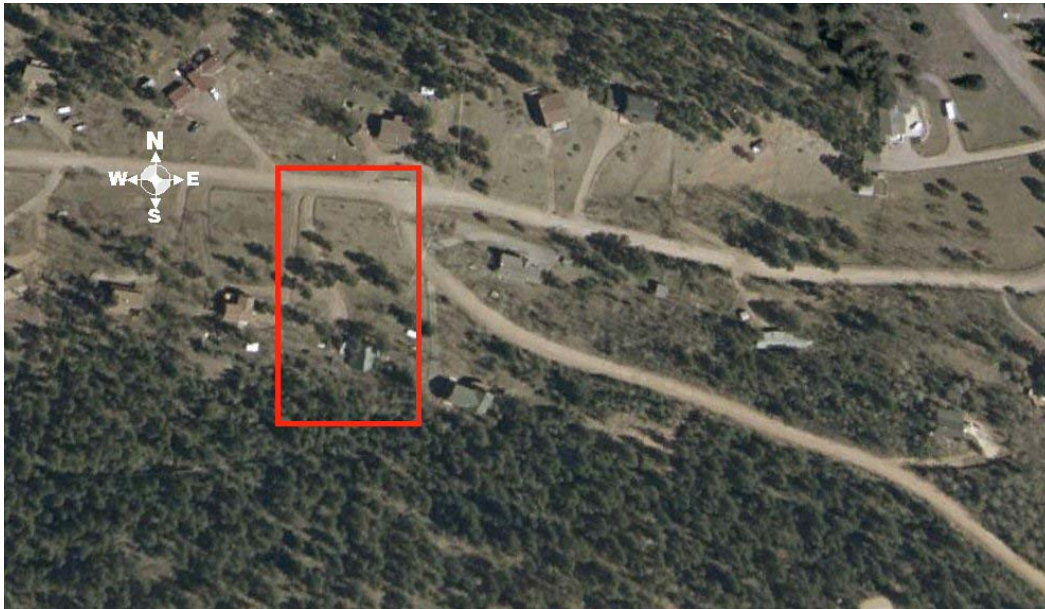
Figure 1
General Site Layout⁷

A general aerial layout of the residential setting is depicted in the aerial photograph below. The subject property is generally outlined in red.

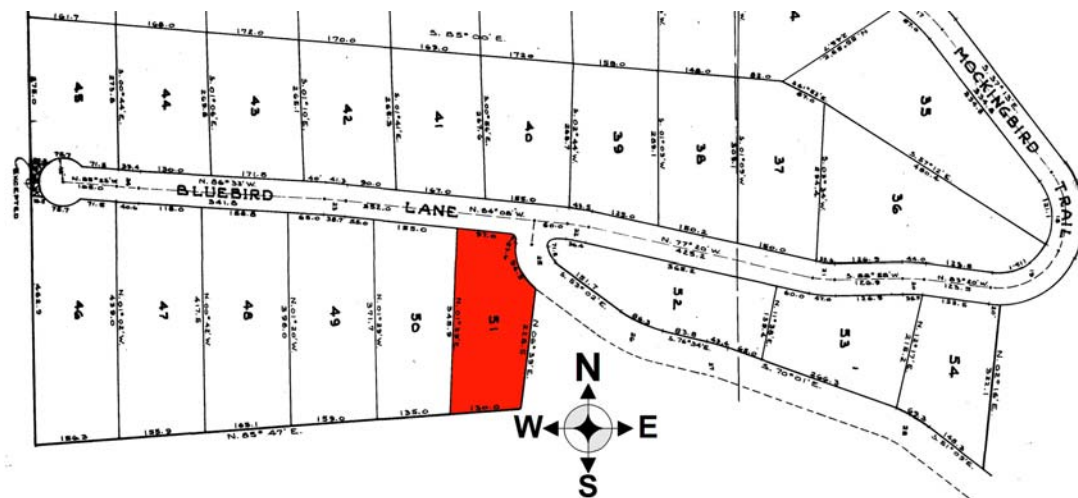
Figure 2
Partial Plat Map

A partial plat map for the property is given below with the subject property in red.

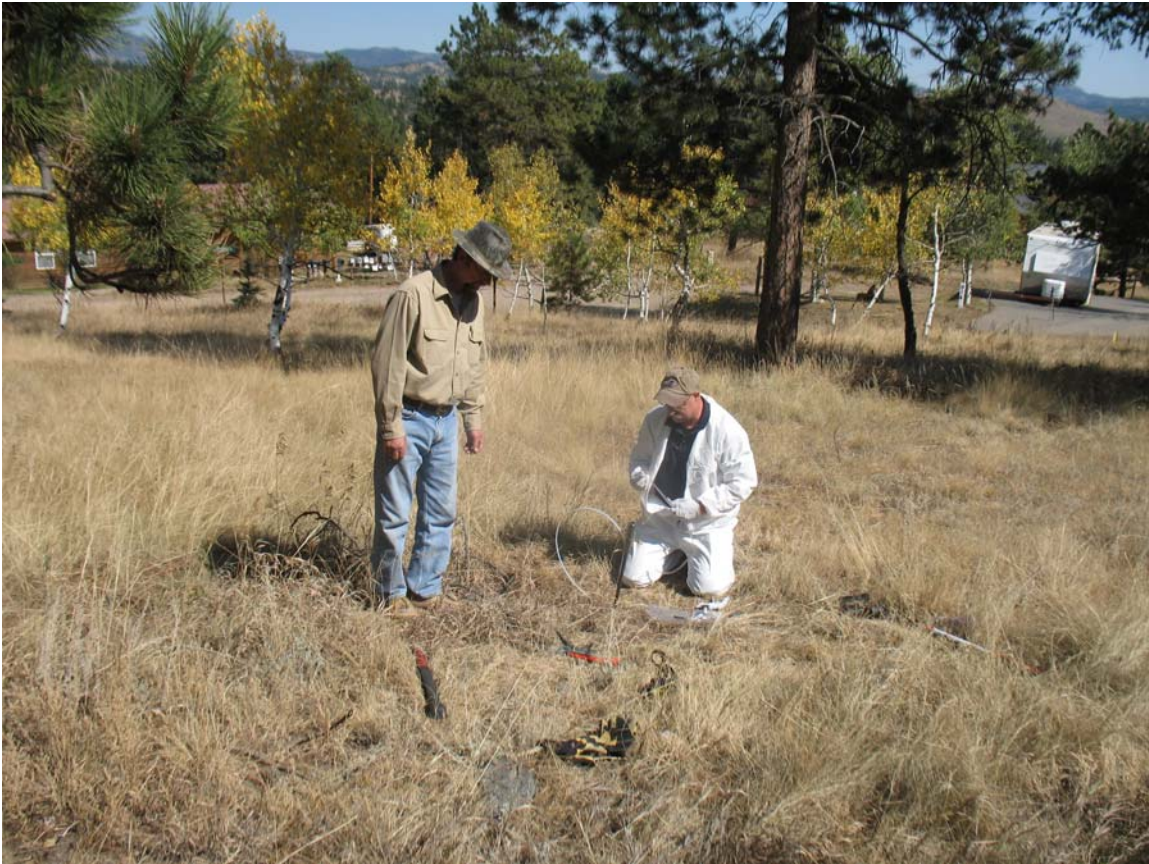
Photograph 1
Direct Push Soil Gas Sampling

Photograph 1, below). Gases from the Tedlar bag are then introduced into suitable instruments for direct reading qualitative analysis (in this case, we measured broad range hydrocarbons and acid gases).
