**Preliminary Assessment
of an
Identified Illegal Drug Laboratory**

**Resulting in a
Decision Statement**

**1354 Burland Drive
Bailey, CO 80421**

July 12, 2011

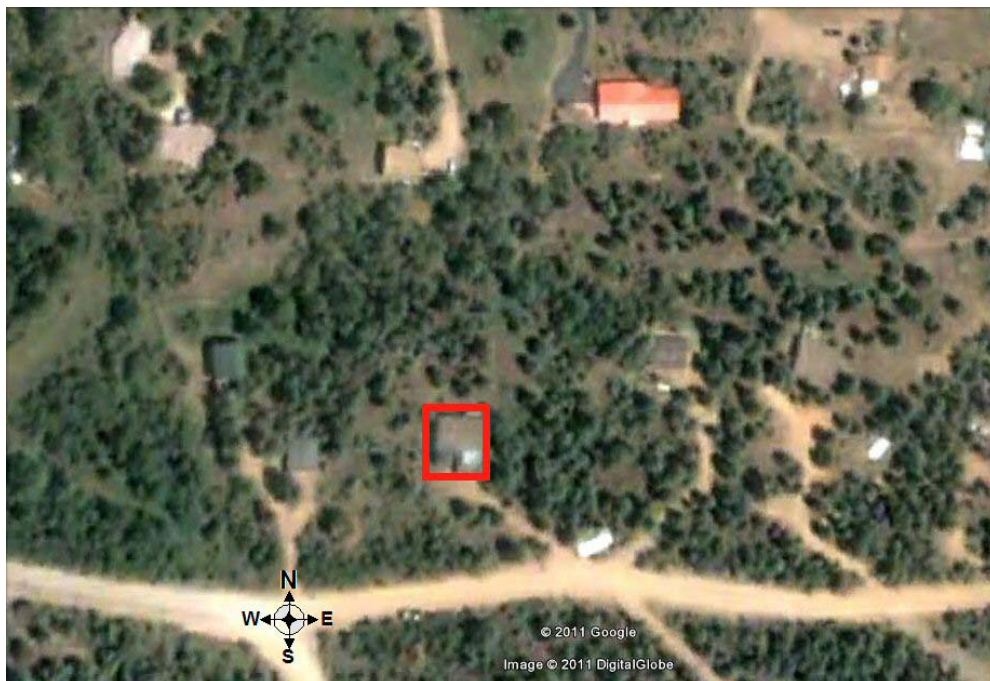
Photograph 1
General Building Layout

In the photograph below, we have presented the general layout of the structure and surrounding features. The structure of is outlined in red.

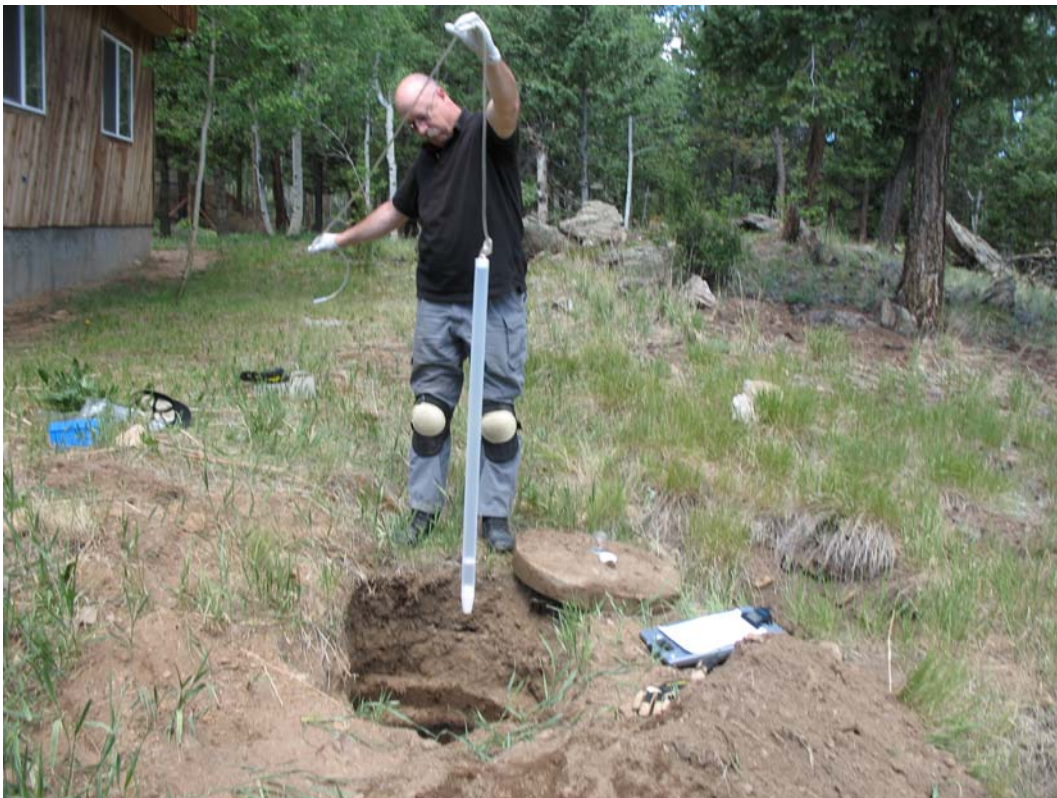
Photograph 3
Coliwasa Stratified Septic Tank Contents

We were able to locate and easily access the holding tank and the septic tank serving the residence. Our visual inspections indicated that the tank was virtually empty. The slight liquid content was devoid of “slick” and bi-phasic liquids, indicating that organic solvents had not been discarded into the septic system. Subjectively, we did not observe any odors associated with cyclic aromatic or aliphatic solvents. The vapor phase hydrocarbon concentration in the headspace above the holding tank liquid was less than 2 ppm.

Using a coliwasa, we attempted to collect a stratified sample from the tank (see Photograph 3). However the depth of liquid was less than four inches, and the collection was not successful.

Based on these observations, we conclude that the septic system and the leach field can be excluded from the remediation process.
