**FORENSIC APPLICATIONS CONSULTING TECHNOLOGIES, INC.**

**Preliminary Assessment  
of an  
Identified Illegal Drug Laboratory  
at  
4386 Eldridge Street  
Morrison, CO 80465**

October 12, 2010

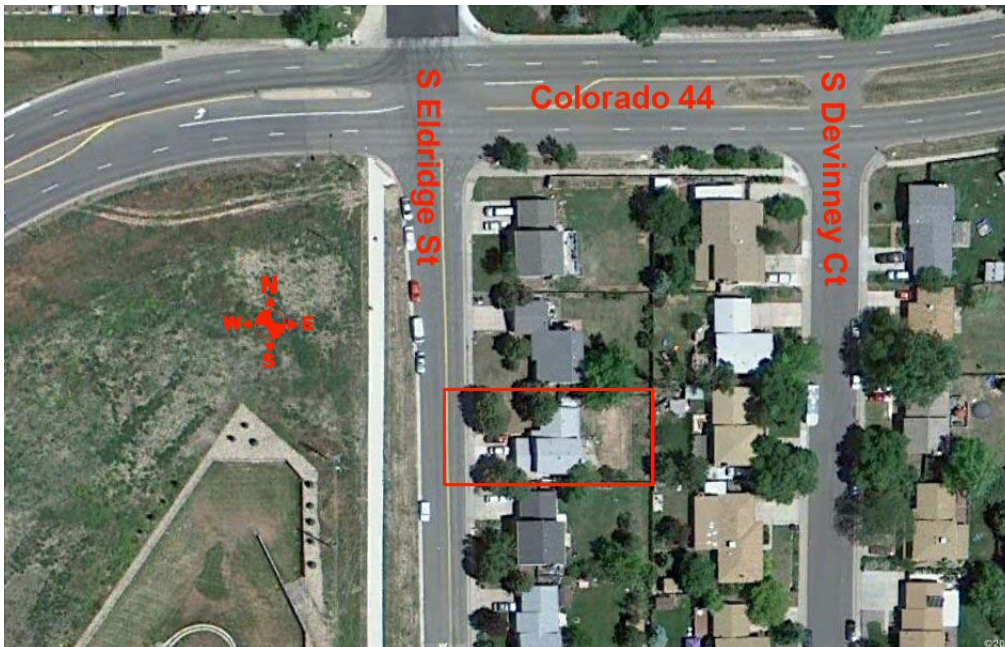
**Figure 1**  
**General Site Layout**

A general aerial layout of the structure is depicted below. The subject property is outlined in red.
