**Preliminary Assessment
of an
Identified Illegal Drug Laboratory
at:**

**61600 Gunnison Road
Montrose, CO 81401-9270**

**Prepared for:
Kennedy, Childs & Fogg, P.C
326 Main Street, Suite 200, Delta, CO 81416**

October 4, 2010

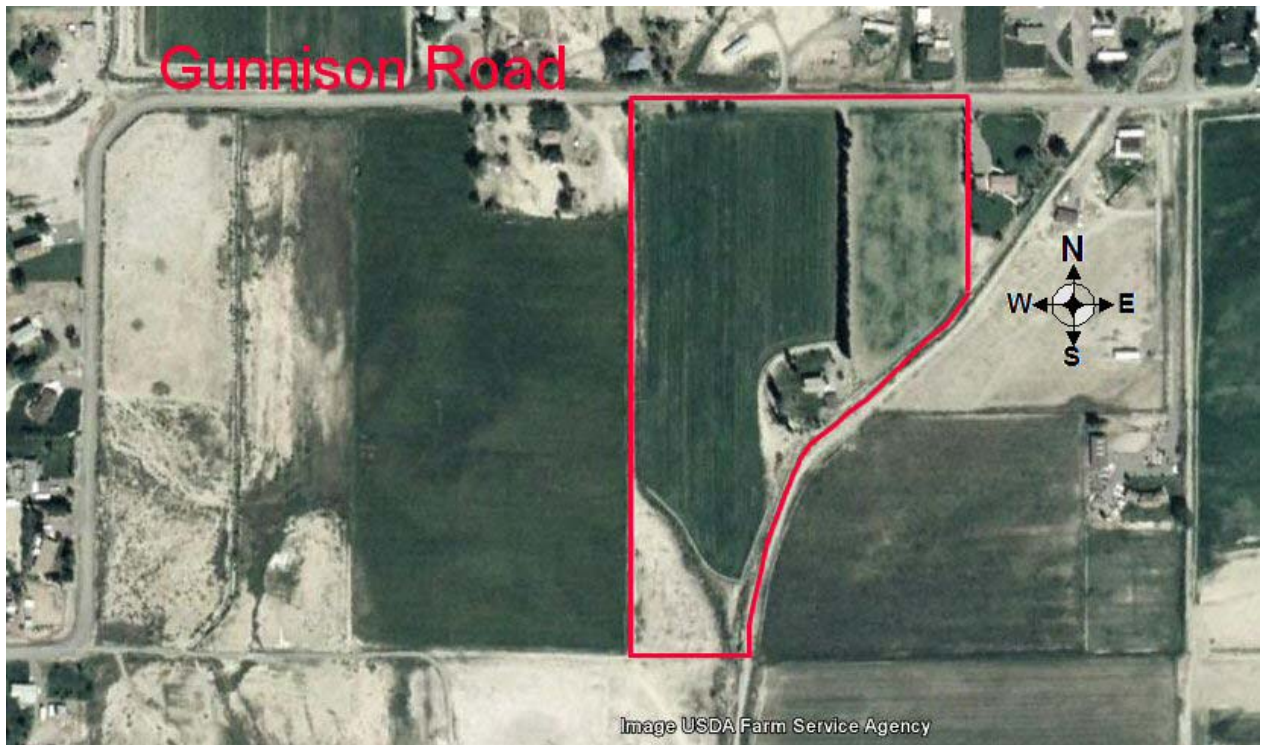
Photograph 1
General Site Layout⁷

A general aerial layout of the subject property is depicted in the aerial photograph below. The property boundary is outlined in red.

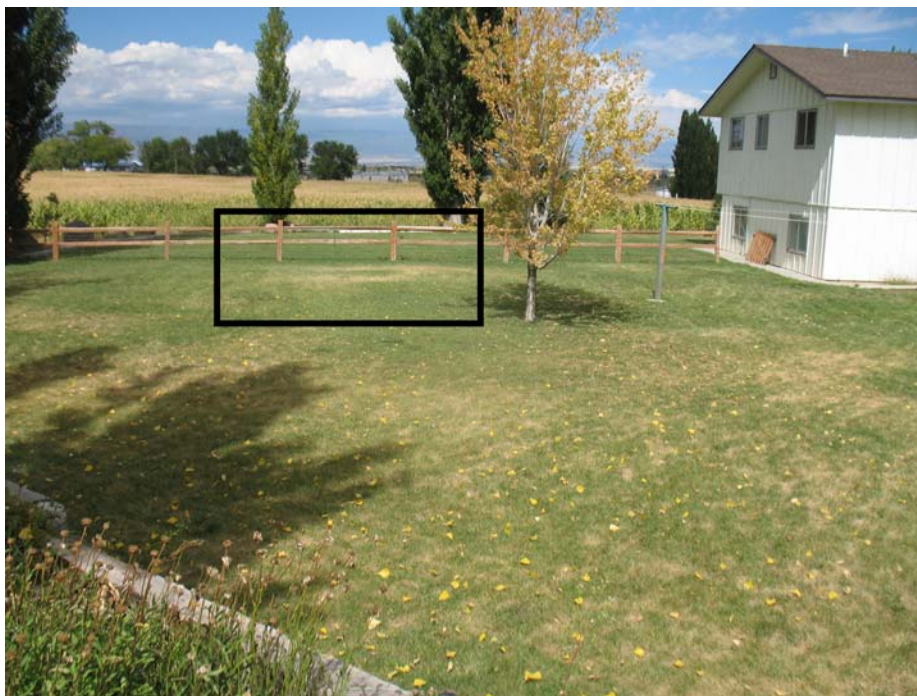
Photograph 3
Stressed Vegetation in the Back (South) Yard

Although not truly a functional space *per se*, the exterior grounds were assessed independently. Although we did observe some evidence of stressed vegetation, that stressed vegetation was not necessarily consistent with illegal waste dumping and may have been associated with the location of the ISDS. A Photograph of the stressed area is provided below.

FACTs did not observe any indications that waste or contaminants from the subject property may have migrated off-site.

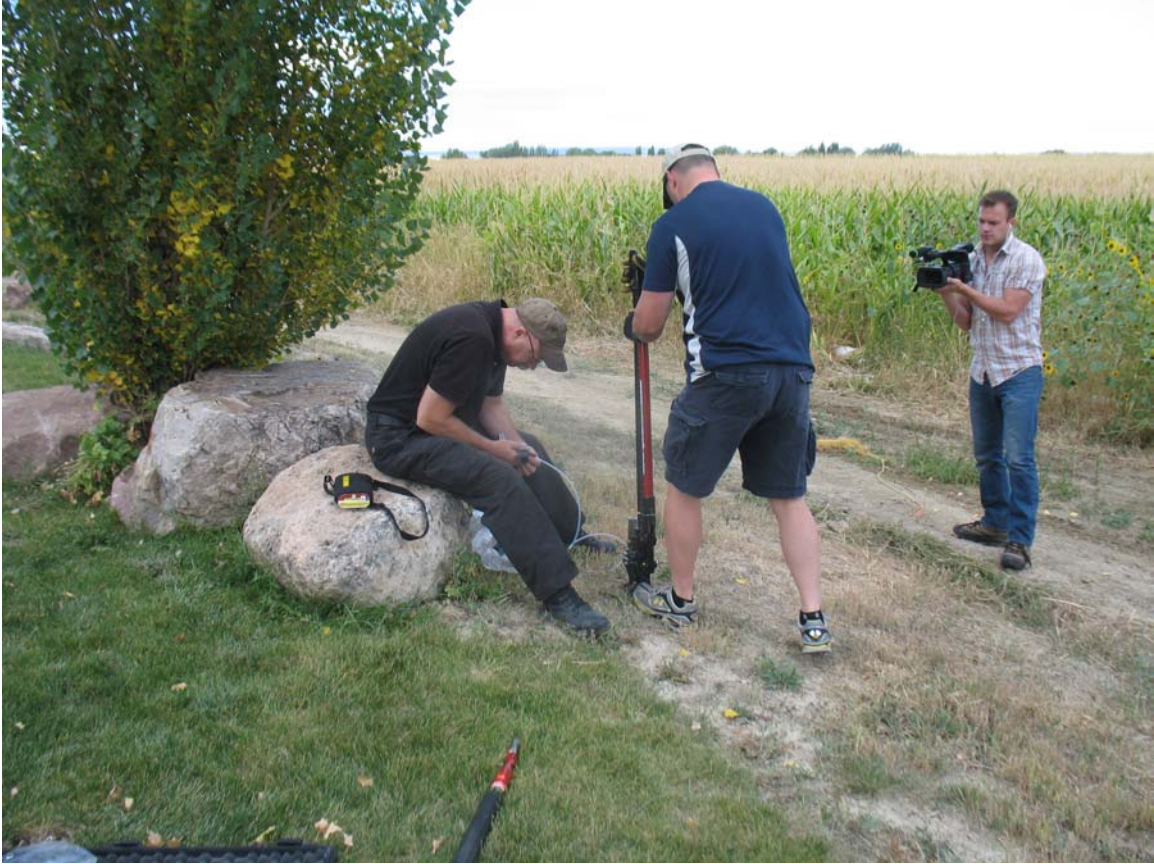
Photograph 4
Direct Push Soil Gas Sampling

To assess the soils around the septic tanks and the leach field, FACTs employed direct push soil sampling techniques, wherein we drove hollow gas sampling tips to a desired depth in the soils. The tip is attached to a length of Teflon® tubing, and using an high vacuum hand pump, soil gases are extracted into a Tedlar® gas sampling bag (See Photograph 1, below). Gases from the Tedlar bag are then introduced into suitable instruments for direct reading qualitative.

(The individual shown in the right side of the photograph is not with FACTs, but rather is the professional videographer, Jack Metier).
