**Preliminary Assessment
And
Decision Statement
of an
Identified Illegal Drug Laboratory
at
1636 Mount Evans Drive
Longmont, Colorado**

May 13, 2010

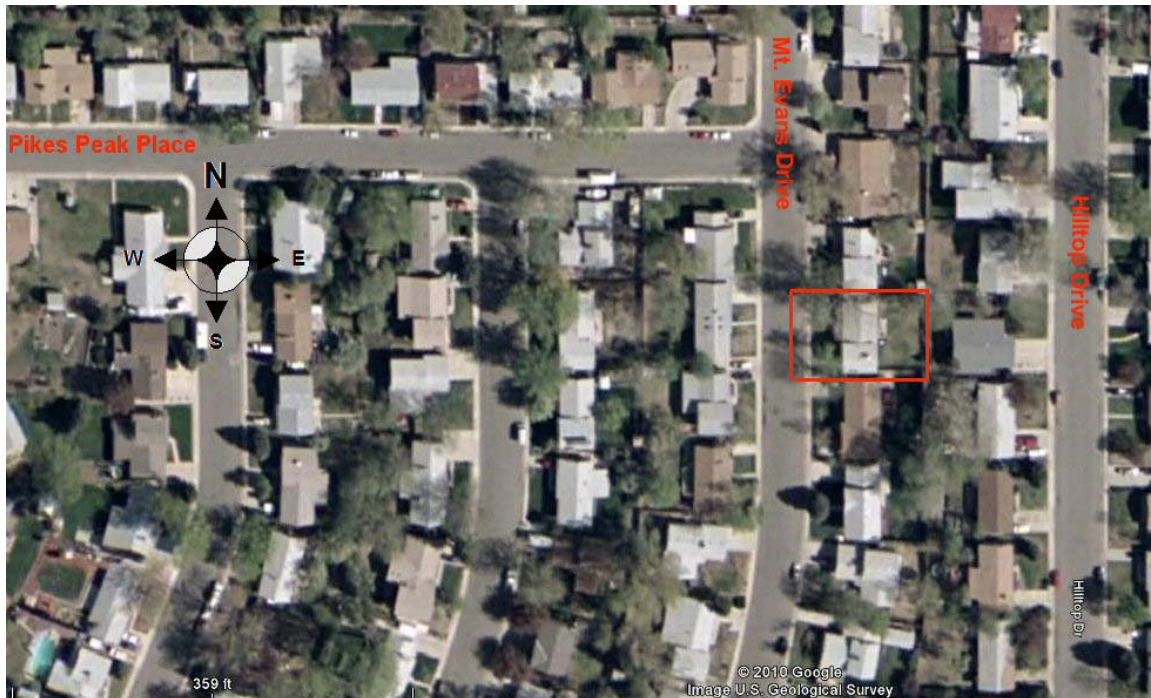
Figure 1
General Site Layout⁶

A general layout of the structures is depicted in the Figure below. The subject property is outlined in red.

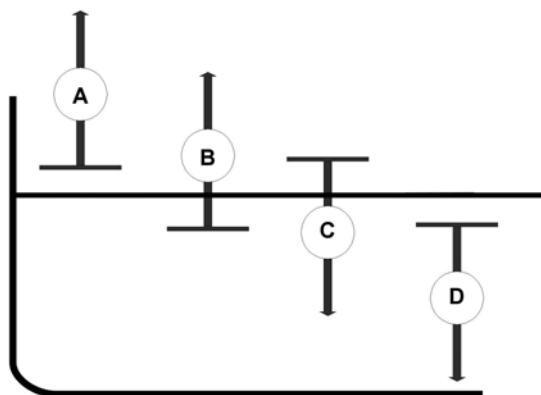
Figure 3
Uncertainty in Reported Values

Compliance, and the decision to remediate or not remediate, is based not only on the reported value, but also on the statistical uncertainty of the results. So, in the drawing below, where the reported value (A) and the LCL are greater than the decision threshold (the horizontal line), we are *confident* the reported value indicates noncompliance. Where the reported value (D) and the UCL are less than the decision threshold, we are *confident* the reported value indicates compliance.

However, there is an ambiguous zone of reported values, such as (B), where although the reported value is greater than the decision threshold, there is a probability the true value is less than the decision threshold. Similarly, where the reported value is less than the decision threshold, there is a probability the true value is greater than the decision threshold (C).

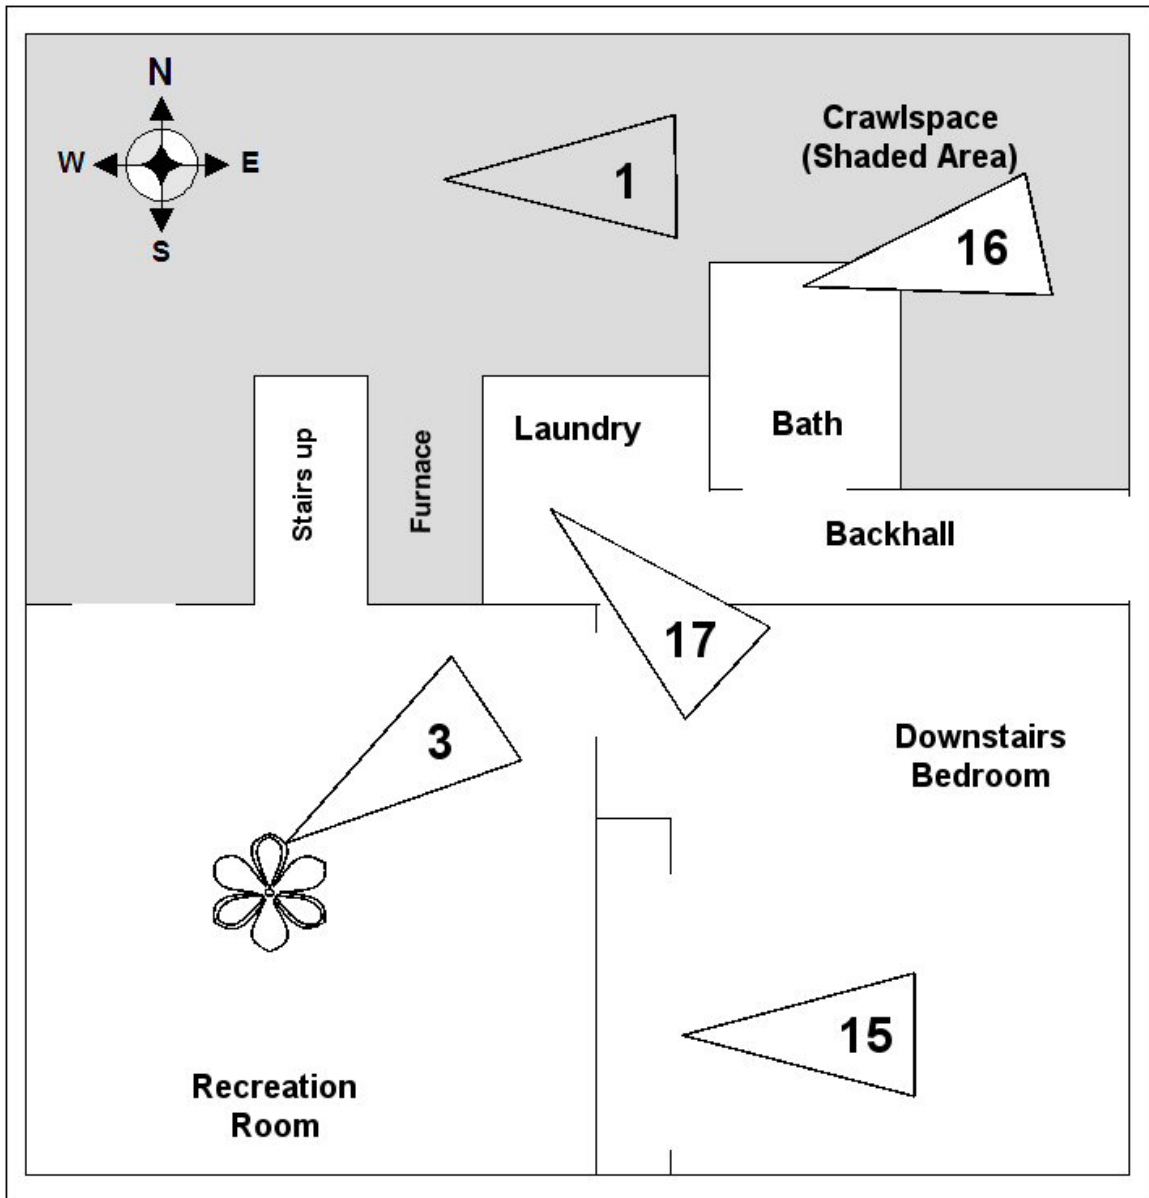
Figure 4
Initial Sample Locations Basement and Crawlspace

In the figures that follow, the sample locations have been presented. The drawings are stylized and not to scale. In the diagrams, the sample locations are indicated by triangles.

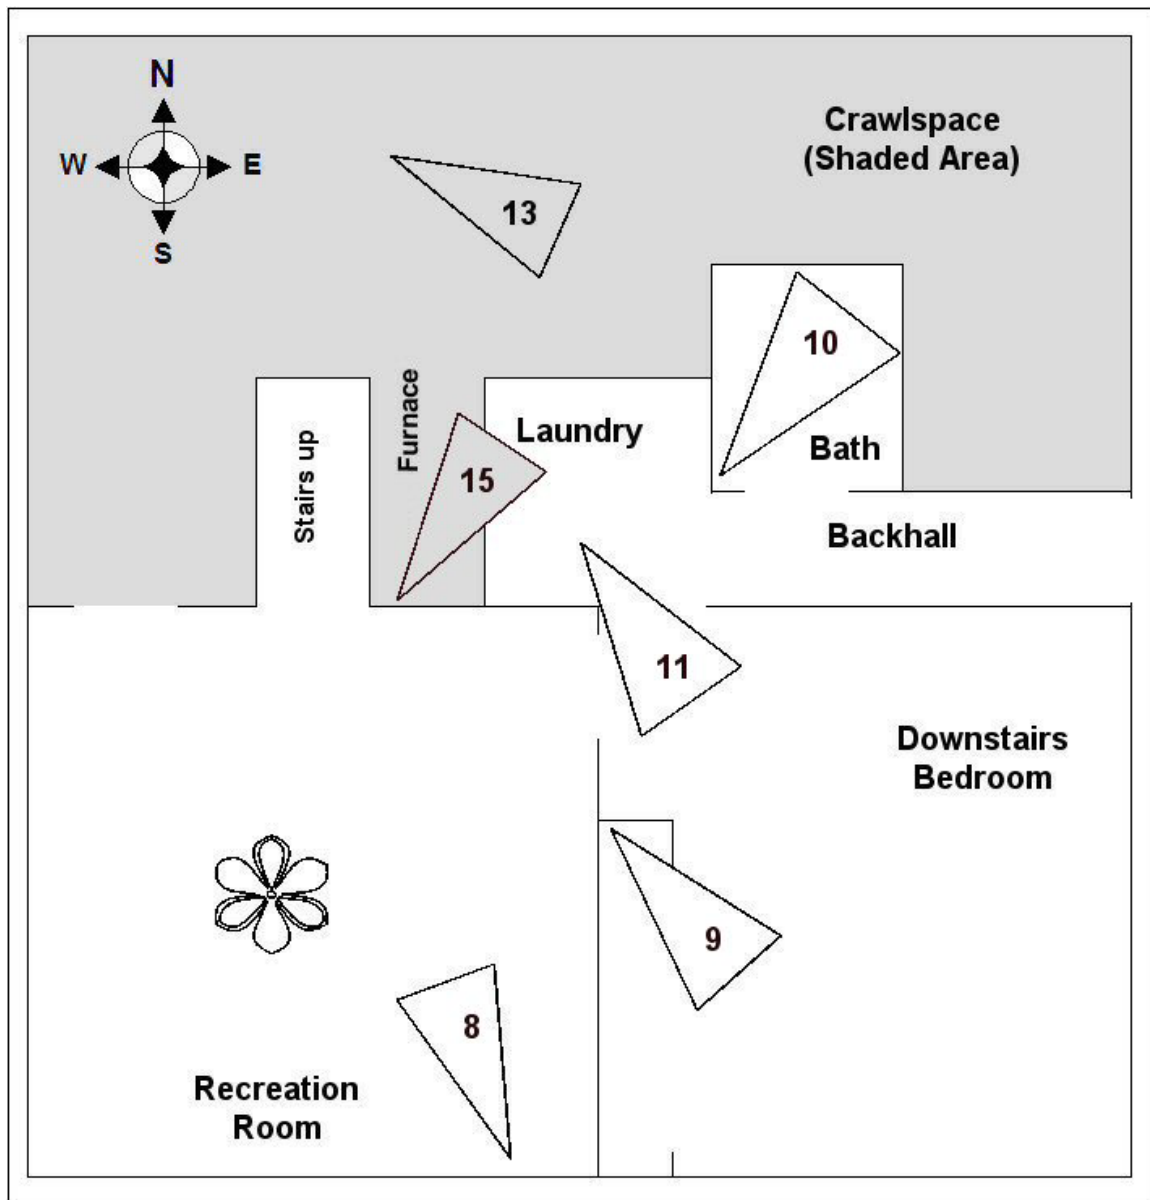
Figure 8
Locations of Final Verification Samples - Basement

The drawing below identifies the location of each verification sample.
