**Preliminary Assessment  
of an  
Identified Illegal Drug Laboratory  
at**

**1040 South Upham Street  
Lakewood, CO 80226-4555**

May 26, 2010

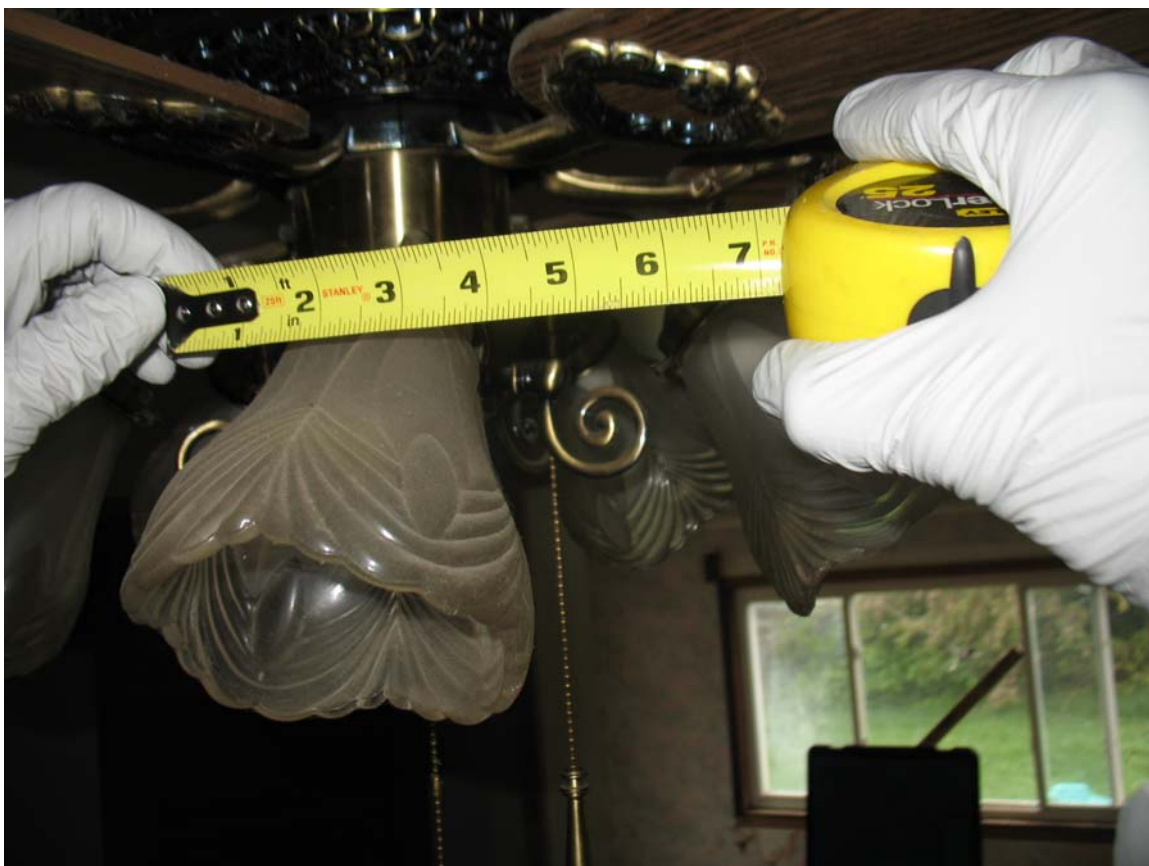
**Photograph 1**  
**Functional Space 1 Sample**

In this case, for example, the selected location consisted of glass shades that were essentially comprised of interconnected rounded trapezoids. Each trapezoidal surface had a three-dimensional topography which increased the actual surface area over the apparent two-dimensional measurements. Good faith efforts are made to estimate the two-dimensional aspects, but no effort was made to incorporate the three-dimensional contributions. As such, the surfaces used to calculate the concentration is biased low, and therefore, the reported concentrations are biased high.

One of the samples collected from this space (UM051210-1), was below the regulatory threshold ( $0.04 \mu\text{g}/100 \text{ cm}^2$ ) and one of the samples collected from this functional space (UM051210-17) was greater than the regulatory threshold ( $2.8 \mu\text{g}/100 \text{ cm}^2$ ).

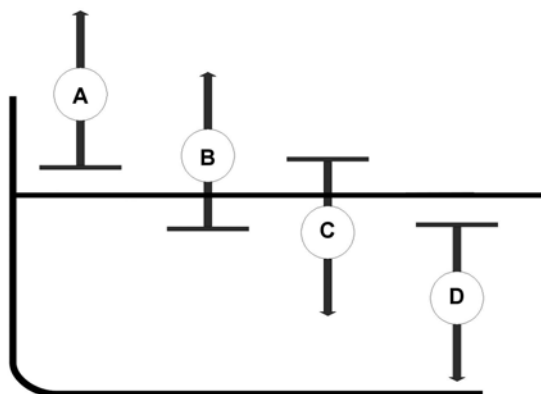
**Figure 3**  
**Uncertainty in Reported Values**

is less than the decision threshold. Similarly, where the reported value is less than the decision threshold, there is a probability the true value is greater than the decision threshold (C).

Standard Industrial Hygiene sampling protocols require that the Industrial Hygienist consider this degree of uncertainty, known as the total coefficient of variation ( $Cv_T$ ), for each method. The  $Cv_T$  includes the uncertainty associated with both the sampling and analytical processes. For many methods, such as this analysis method, the degree of analytical uncertainty is known and published, and is generally small. However, for field methamphetamine sampling, the statistical uncertainty is generally very large. When we analyze field data from fully characterized properties, we see that the variation of concentrations from the building as a whole usually exhibits a lognormal distribution. As such, geometric standard deviations can be as large as 3.0. This distribution is similar to that reported elsewhere.<sup>15, 16</sup>
