**Preliminary Assessment
of an
Identified Illegal Drug Laboratory
at:**

**3183 Vaughn St.
Aurora, CO**

January 28, 2011

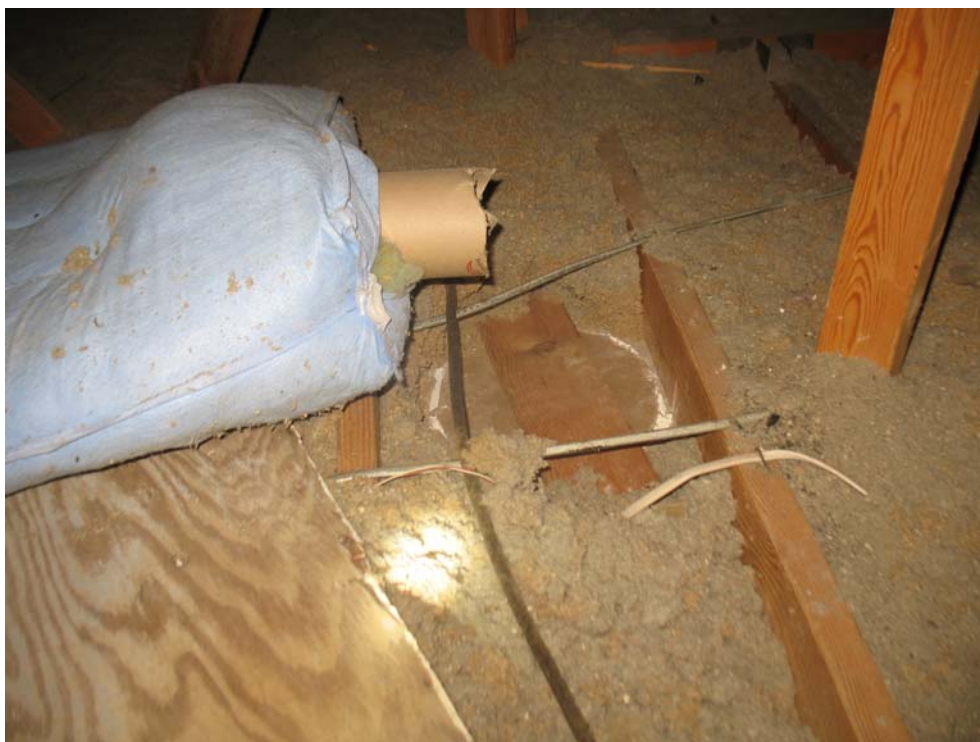
Photograph 1
Marijuana Filtration Device

The attic essentially has the same plan as the ground floor. Upon entry into the attic we observed a makeshift marijuana filtering device manufactured from a seat cushion hidden in the attic. (See Photograph 1)

The filtration device had originally been inserted through the hole in the living room ceiling (the circular damaged area in the central portion of the photograph).
